Brightwood Park Ecological Mapping Report – September 2020

Prepared for Tim Van Epp, Town of Westfield Green Team
Prepared by Michael Van Clef, Program Director, New Jersey Invasive Species Strike Team

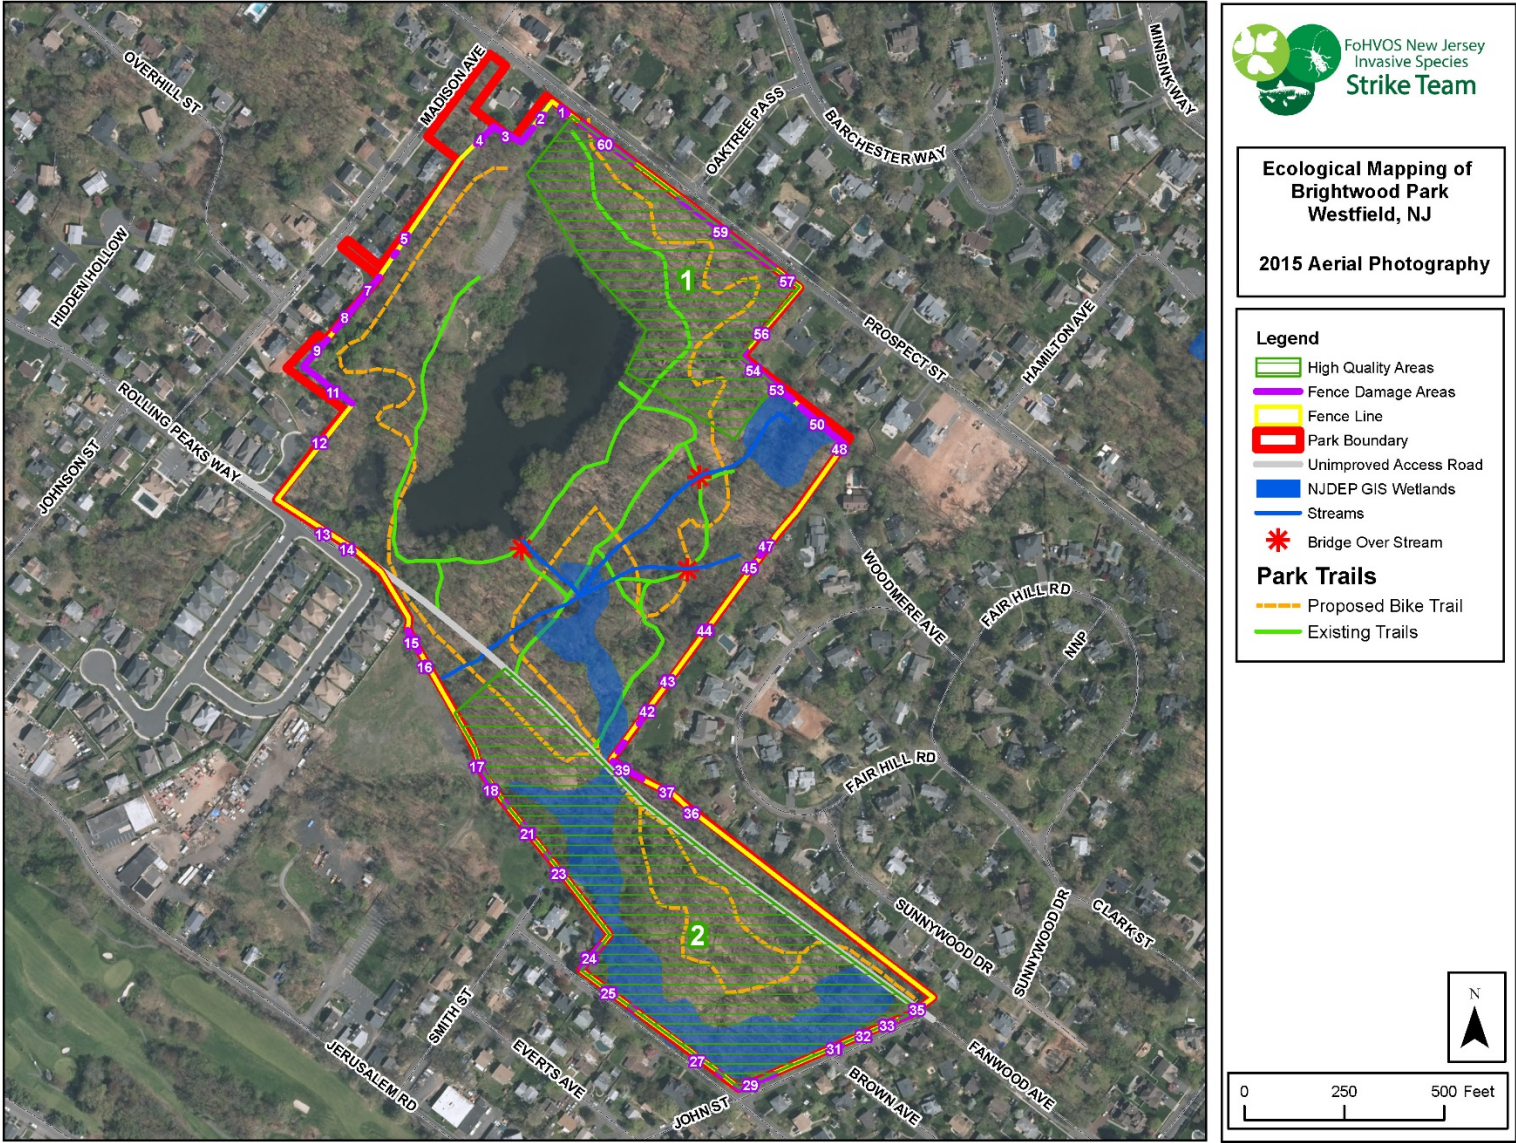
Map 1. Brightwood Park Ecological Mapping Evaluation – Entire Park

The entire fence perimeter is approximately 7,310 feet. A summary of fence condition by damage type is provided in Table 1 with details of 60 mapped locations provided in Table 2. Approximately 27% (1,975 feet) of the fence requires removal of dense vegetation (6%), extension of fence bottom

to reach ground level (10%) or significant repair / replacement (11%). Approximately 3% of the fence perimeter includes sections replaced by neighbors and/or replaced by the Township in the recent past.

The entire fence perimeter is 6 feet in height. It is recommended that two additional wire strands be placed at 1-foot intervals to increase the effective height to 8 feet.

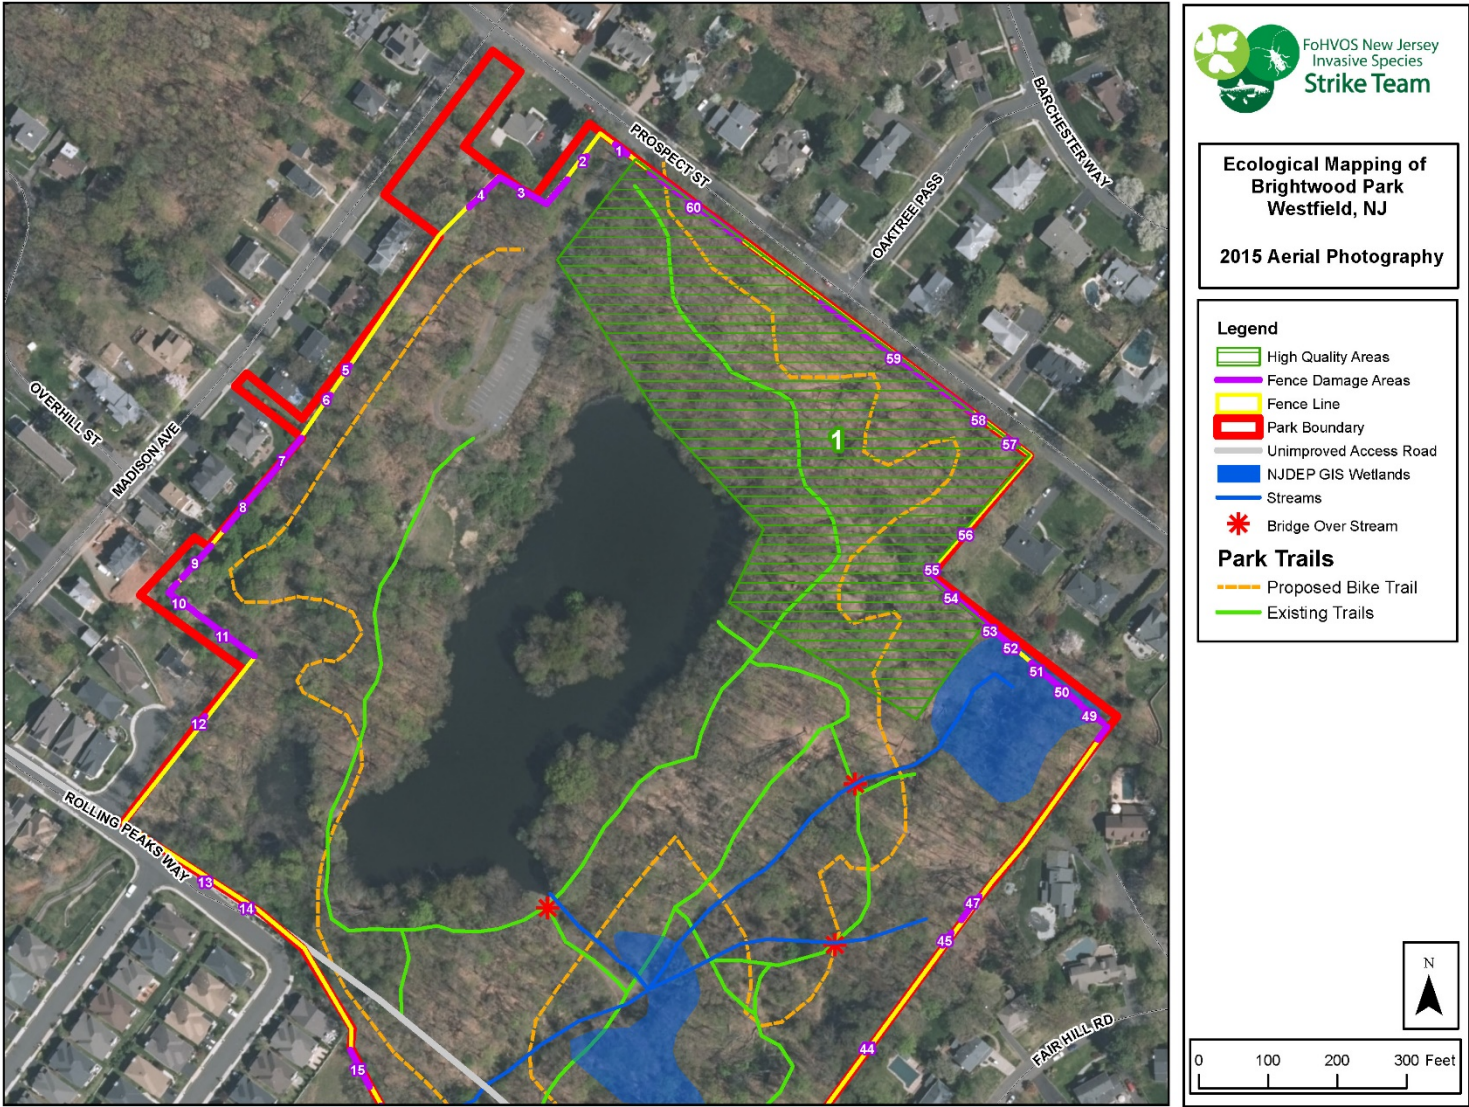
Map 1A. Brightwood Park Ecological Mapping Evaluation – Northern Portion of Park

Area #1 Attributes:

- Area #1 is 5.5 acres with a perimeter of 2,350 feet (includes 1,050 feet of existing Park perimeter fence)
- Area #1 boundary was drawn to minimize interference with existing trails, but two self-closing pedestrian gates are required on the existing gravel trail.
- Non-infested or lightly infested areas cover 75% of Area #1.
- Heavily infested areas (especially Chinese Wisteria but also Japanese Knotweed, Multiflora Rose and others) are included in Area #1 so that post-treatment recovery is hastened by the lack of deer browse.
- There are no NJDEP GIS wetlands in Area #1.
- Area #1 features mature trees including Red Oak, White Oak, Black Oak, Sweet Birch, American Beech, Mockernut Hickory, Flowering Dogwood, Maple-leaved Viburnum, Lowbush Blueberry, Black Huckleberry, Sarsaparilla and Pennsylvania Sedge. The entire area has sparse native wildflowers due to excessive deer browse.

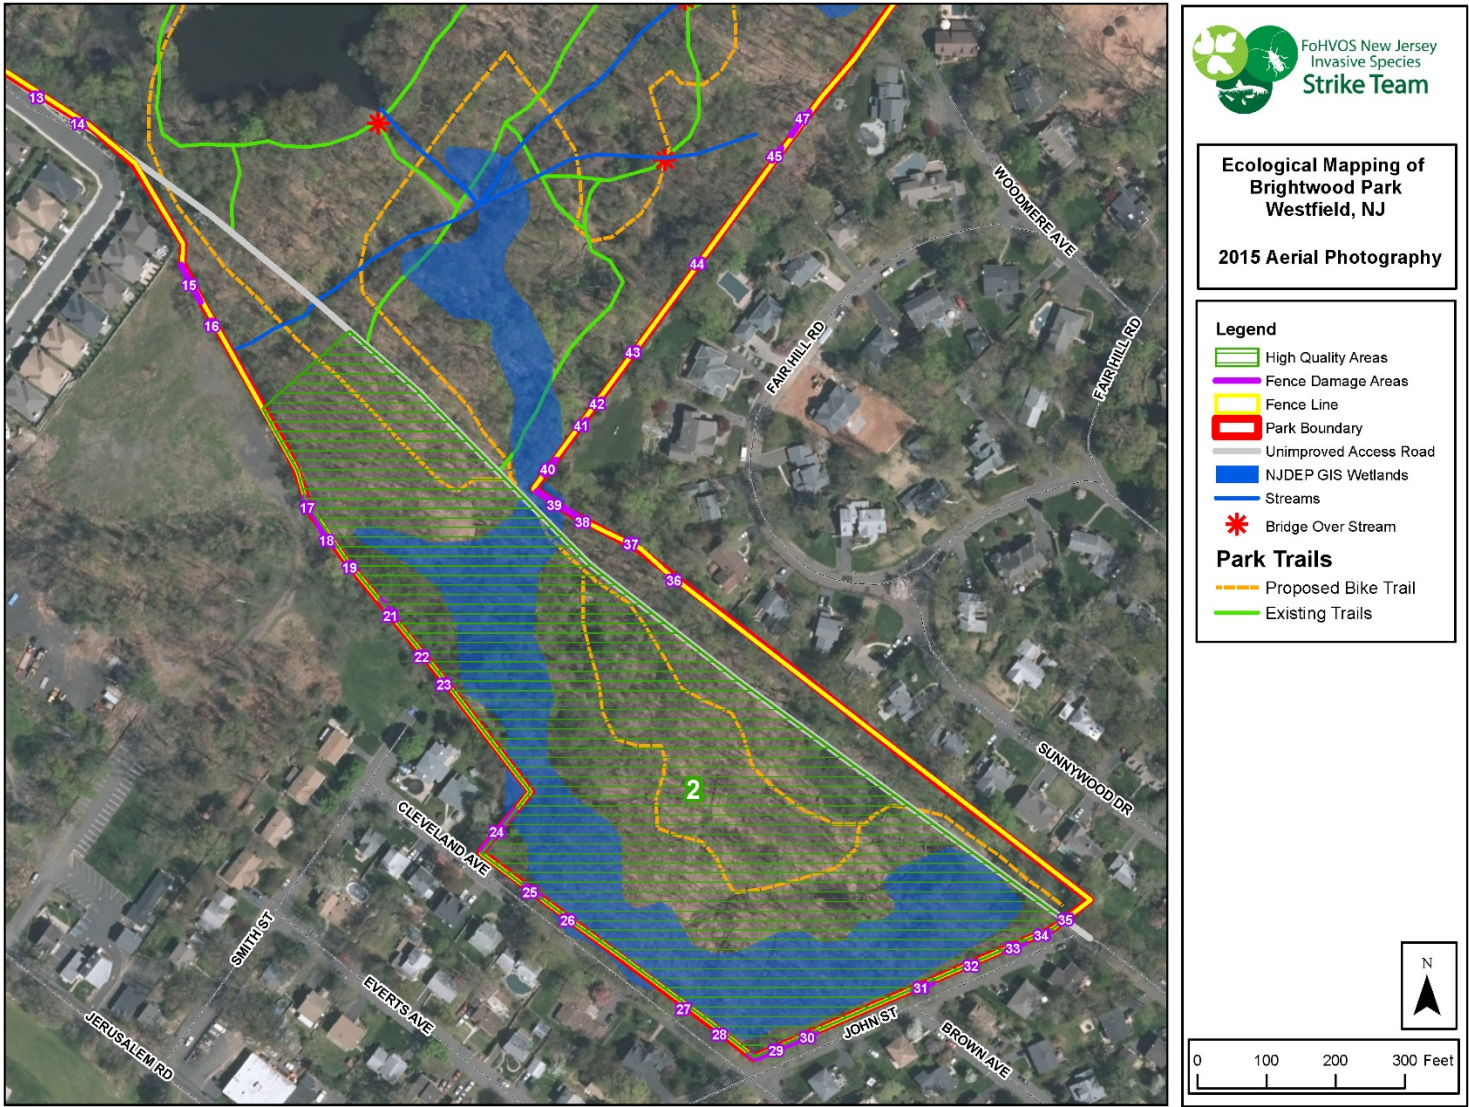
Map 1B. Brightwood Park Ecological Mapping Evaluation – Southern Portion of Park

Area #2 Attributes:

- Area #2 is 9.5 acres with a perimeter of 3,290 feet (includes 1,780 feet of existing Park perimeter fence).
- There are no trails within Area #2, but two self-closing pedestrian gates off of the existing unimproved road are recommended for stewardship access (at eastern and western ends of area).

- Non-infested or lightly infested areas cover 75% of Area #2 (two distinct 'clean areas' occur on the western and southeastern portions of Area #2).
- Heavily infested areas (located in between the cleaner portions of the area) are included in Area #1 so that post-treatment recovery is hastened by the lack of deer browse.

- There is a significant amount of NJDEP GIS wetlands in Area #2, but any new fencing would primarily be installed along the edge of the unimproved access road with only a small portion constructed in uplands (175 feet, forming the western boundary of Area #2).

- Area #2 features both dry upland and wetland / transitional plant communities. Dry areas include Chestnut Oak, White Oak, Black Oak, Red Oak, Mockernut Hickory, Sweet Birch, Flowering Dogwood, Sassafras, Lowbush Blueberry and Pennsylvania Sedge. The wetland and transitional communities include Tulip Poplar (including very large specimens), Swamp White Oak, Red Maple, White Oak (including very large specimens), Red Oak (including very large specimens), Black Tupelo, Ironwood, Sassafras, Lowbush Blueberry, Black Huckleberry, Bracken Fern, Christmas Fern, Wood Reed and New York Fern. The entire area has sparse native wildflowers due to excessive deer browse.
